Interrogating Early India

Excavation at Lalpahari (Lakhisarai, Bihar) in 2018–2019

Anil Kumar, Eshan Harit and Tanmoy Mondal

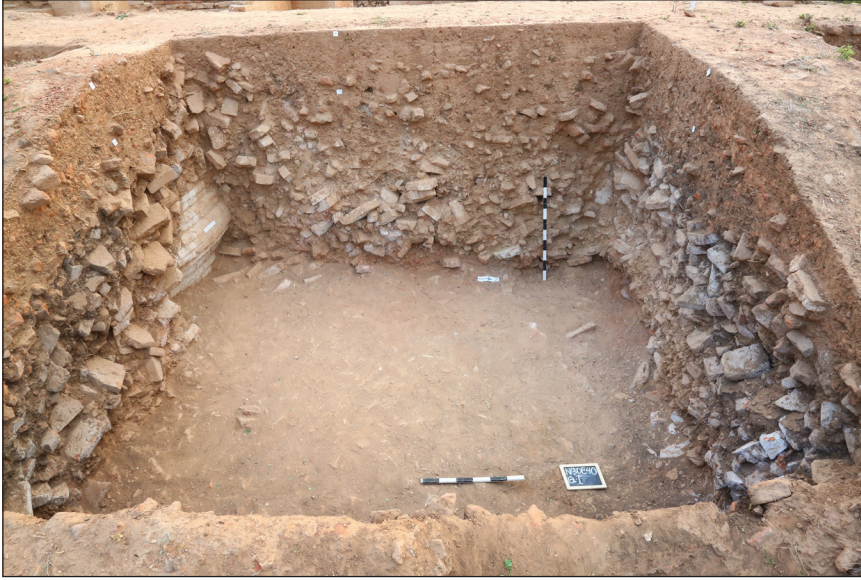
FIGURE 7.1: General view of trench N30E40

The first trench to be excavated in the second season was N30E40 (Fig. 7.1). This is located on the north-eastern corner of

the mound. N30E40 is structurally located between the eastern part of the main entrance and the north-eastern corner bastion. On excavating, a small brick bastion was unearthed mostly from the fourth quadrant of this trench. The front wall of this fortified structure, which stretched on both sides of the bastion, has mostly perished. The base of the wall probably lies buried beneath the main trench baulk. The debris in this trench predominantly consisted of battered bricks and lime plaster. The virgin layer was found in this trench at a depth of about three metres. A further analysis of this data along with the help of computer aided design can help in estimating the height of the wall. Approximately 25 complete bricks were found. Their approximate dimension was 35 cm × 28 cm × 8 cm. Many of these bricks had floral designs and other patterns on them. The sizes and designs of the bricks were premeditated and engraved before burning. This goes on to show the expertise and the precision applied in the construction of this structure.

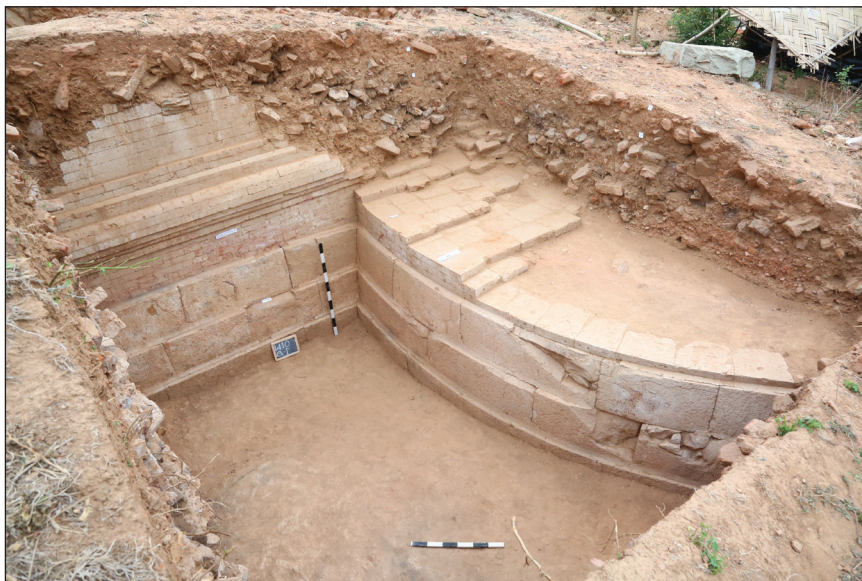
FIGURE 7.2: Corner bastion with stone base

Another trench excavated in the north eastern part of the mound was N40E40. The first quadrant of this trench was excavated in the first season. In the first season, only part of a circular bastion was excavated. Hence, in the second season the fourth quadrant of this trench was laid out and systematically excavated. This was the first corner bastion to be completely excavated (Fig. 7.2). By the end of this season when all the bastions were at least partially excavated few important discoveries were made. The corner bastions with a diameter of approximately 3.75 m were located in the four corners of the structure. They are significant as they are larger than other bastions and have a stone base. The smaller bastions, eight in number, are all completely made of bricks.

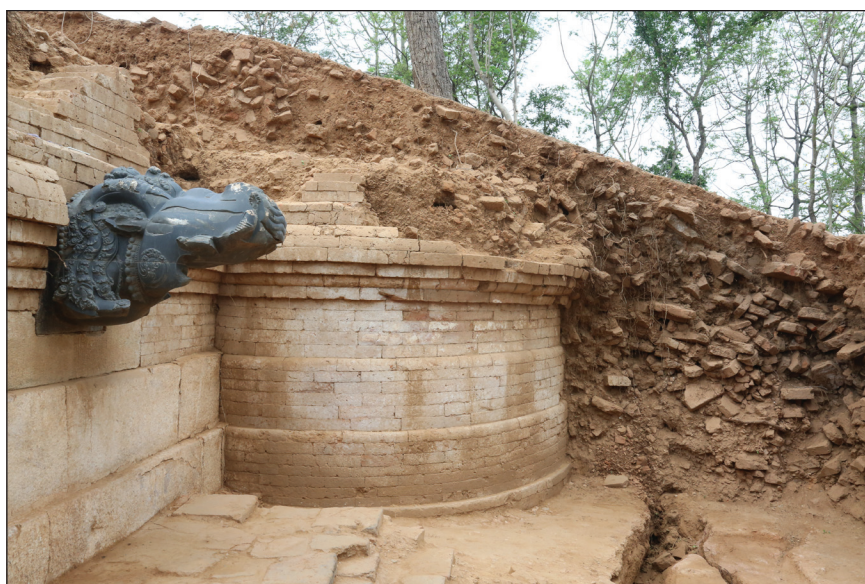
FIGURE 7.3: Gargoyle projecting from wall

On completion of the excavation in the north-eastern corner of the mound, northern part was taken up. N40E30, a trench located in the northern part of the site was excavated in the first season. This trench was located above the structure's north eastern corner bastion and the smaller brick bastion at about 6m distance on the northern side. The outer wall ran between the two structures. A gargoyle was found protruding from the outer wall (Fig. 7.3). The inlet of this drain was found in the corner of verandah area in trench N30E20.

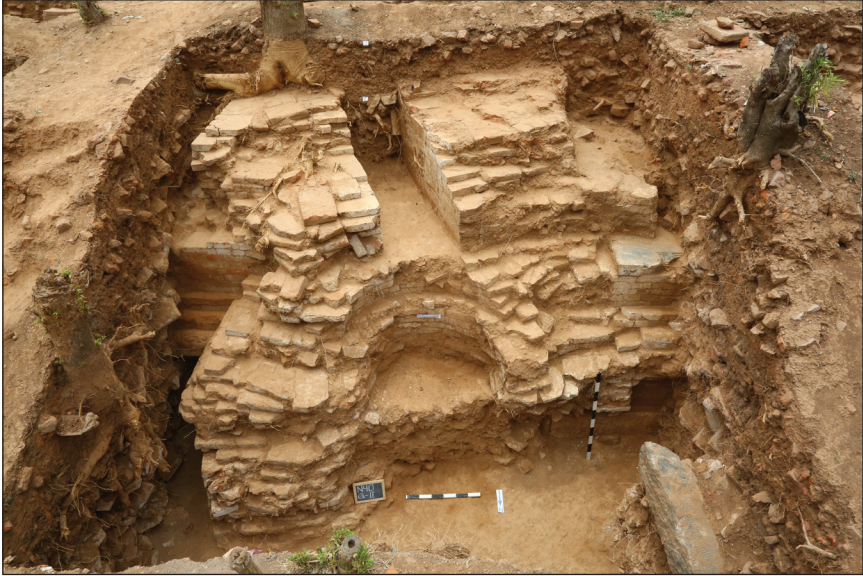
FIGURE 7.4: Broken brick bastion at N40E10

The excavation progressed westward into trench N40. This trench has seen multiple anthropogenic activities in the last few decades. The outer wall located in first quadrant of N40E10 continued in the second quadrant of N40. In this quadrant the second small brick bastion on the north side was located. Half of this bastion has completely weathered away leaving only a semi-circular structure (Fig. 7.4). The finds of great amount of brick debris confirmed this fact. In the following quadrant (first) the outer wall was located which ran west from the small brick bastion. This wall was also highly ornamented. Architectural fragments were located in this region. It is interesting to note that contrary to earlier instances in trenches like N30E40 (described above), the fragments of this portion of the wall are made of polished black stone. These fragments have floral designs on them. A broken sculpture of a female was also located in this region. These were all part of the wall which finally goes on to merge in the north-western corner bastion in trenches N40W10

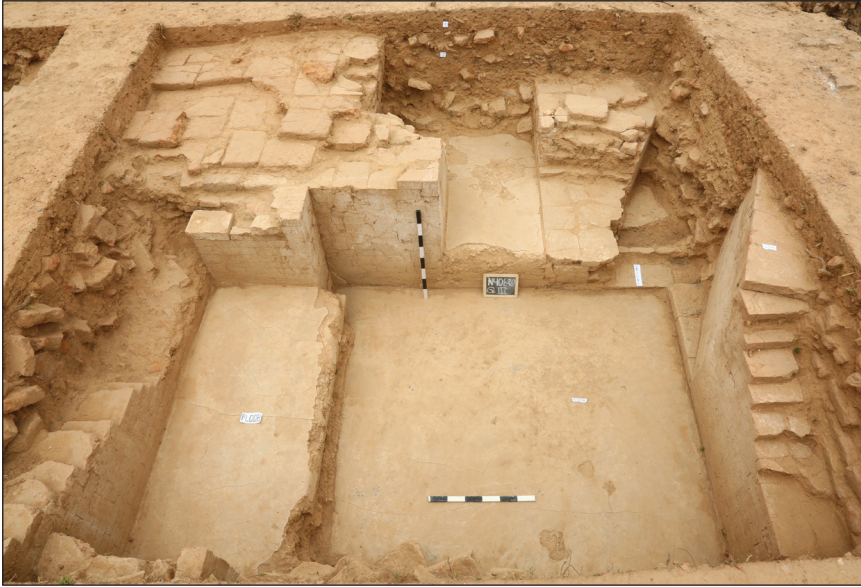
FIGURE 7.5: Cell in trench N40E20

In the northern part of the mound which has been discussed till now, the structures on the outer portion has mostly been discussed. However, excavations were also conducted in the inner parts of the structure which often formed the third and the fourth quadrants of the above mentioned trenches. All these quadrants had cell structures in them. A symmetrical plan can be observed. The cells are of the same size and are located side by side along the east west axis in the northern part of the mound (Fig. 7.5). The different floor levels in all the cells were lime plastered. Only one of the cell's floors has survived along with the lime plastered platform. In others, the floor was probably destroyed over the years. The design of the cells is fixed. A passage leads into the cell from the corridor. The cell has lime plastered floor and a

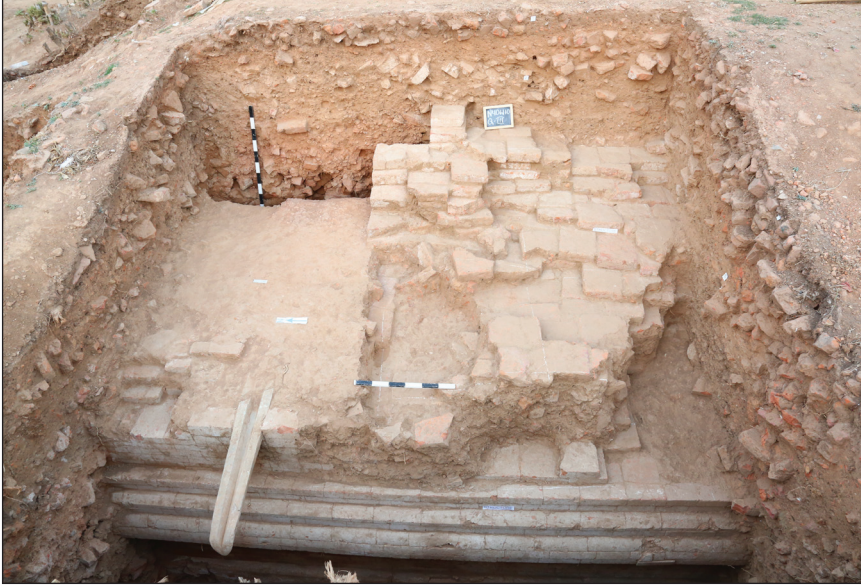
FIGURE 7.6: Drain exposed in trench N40W10

platform made of lime and sometimes coloured. The second passage in the cell leads to a higher platform which is connected to a drain (Fig. 7.6). This platform was probably some sort of washing area attached to each cell. The drains that come out of each cell had mostly collapsed except for a few instances where they survived the ravages of time.

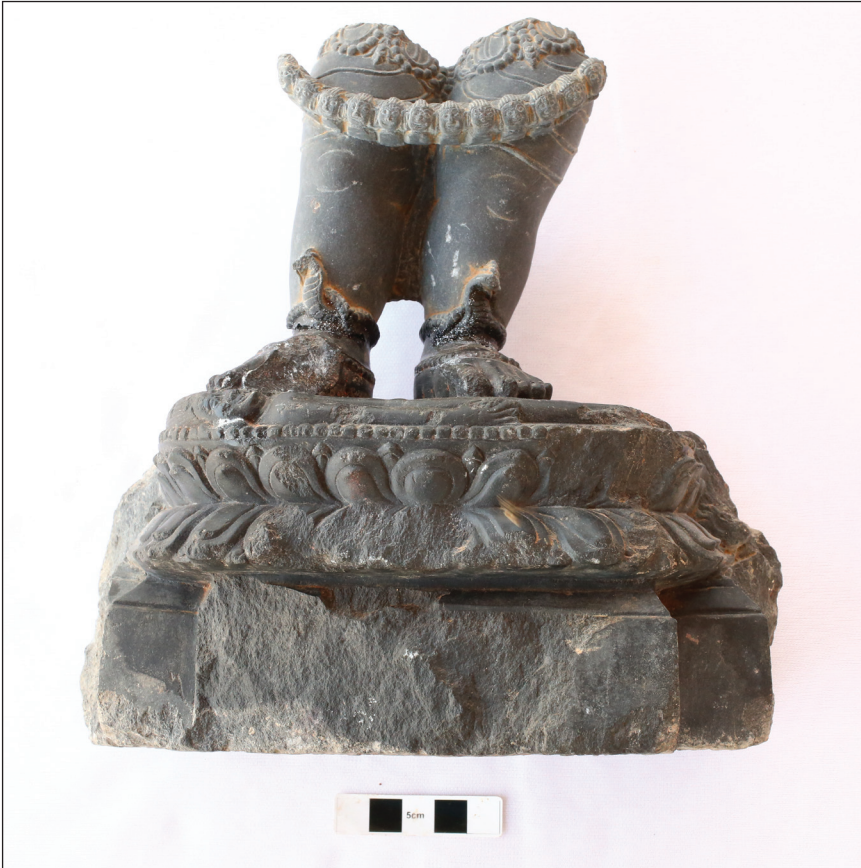
FIGURE 7.7: Stone image of Mahākāla

entering the sanctum area. In N20, huge dressed stone boulders were scattered all along the trench. These probably were part of the structure in the sanctum area that has collapsed. In the baulk of one of the quadrants, a broken sculpture was recovered (Fig. 7.7). The raw material of the sculpture was black stone. The region between the knee and the ankle of the sculpture was found. On probing the site, a broken pedestal was also found lying in the modern temple area. This broken lower part of the sculpture did fit the pedestal.

The sculpture represents a human figure wearing thirteen human heads as garland. Snakes are coiled around his ankle like

anklets. It is standing on another human figure on a lotus pedestal. The figure may be identified with Mahākāla, a Buddhist Protector deity of the Hevajra *maṇḍala*. The presence of Mahākāla near the entrance of the sanctum area once again hints at the structure designed like a Buddhist *maṇḍala*. Further, it was reported by the locals that the lintel representing Avlokiteśvara and Mañjuśrī was also found in the fourth quadrant of N20. It was argued earlier that trench N20W10 had a stone entrance which has now collapsed. These objects were probably decorative sculptures near the entrance to the sanctum area. However, despite all these findings the *maṇḍala* hypothesis can't be argued with certainty without further work.
